Department of Veterans Affairs
 Northern Arizona Veterans Affairs Health Care System (NAVAHCS)
 Outpatient Clinic - Building 117
 Prescott, Arizona

Asbestos-containing Material Locations - Main Level, North

Department of Veterans Affairs
 Northern Arizona Veterans Affairs Health Care System (NAVAHCS)
 Outpatient Clinic - Building 117
 Prescott, Arizona
Asbestos Sample Locations - Main Level, North

ASBESTOS PLM REPORT: EPA-600/M4-82-020 & EPA METHOD 600/R-93-116

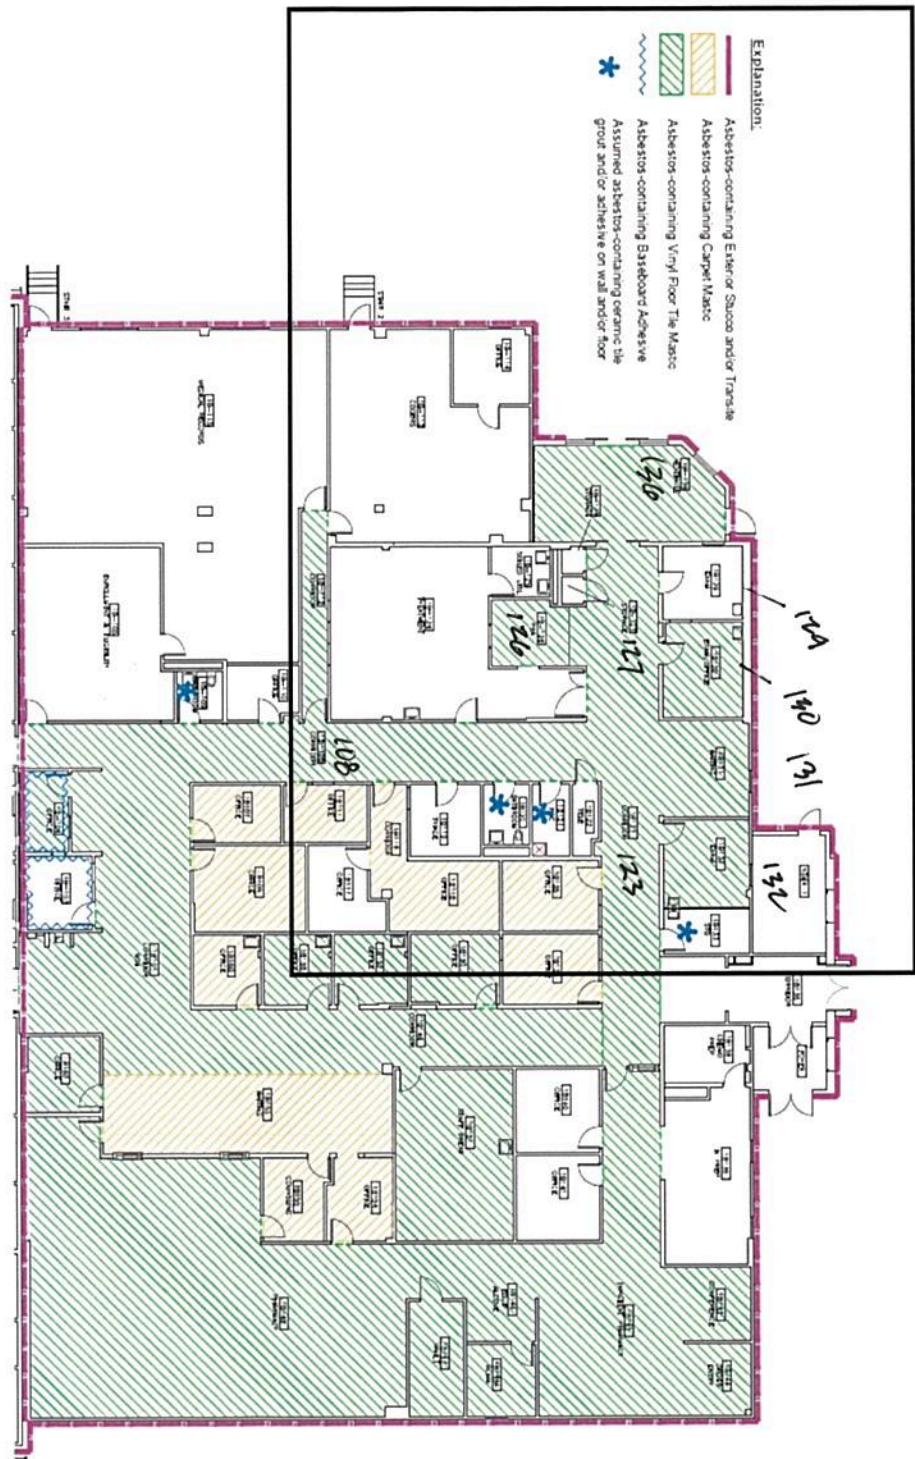
PROJECT No: 11P-A3138
 SHEET: 4 ML
 DRAWN BY: S. RAYMAN
 DATE: 2/1/12
 REVISION BY: M. B. B. B.
 DATE: 4-2-12
 REVIEWED BY:
 DATE:

- Explanation:**
- Asbestos-containing Exterior, Solid and/or Translucent
 - Asbestos-containing Carpet/Marble
 - Asbestos-containing Vinyl Floor Tile/Marble
 - Asbestos-containing Baseboard/Adhesive
 - Assumed asbestos-containing ceramic tile grout and/or adhesive on wall and/or floor
